## SECTION 4: SAFETY ISSUES

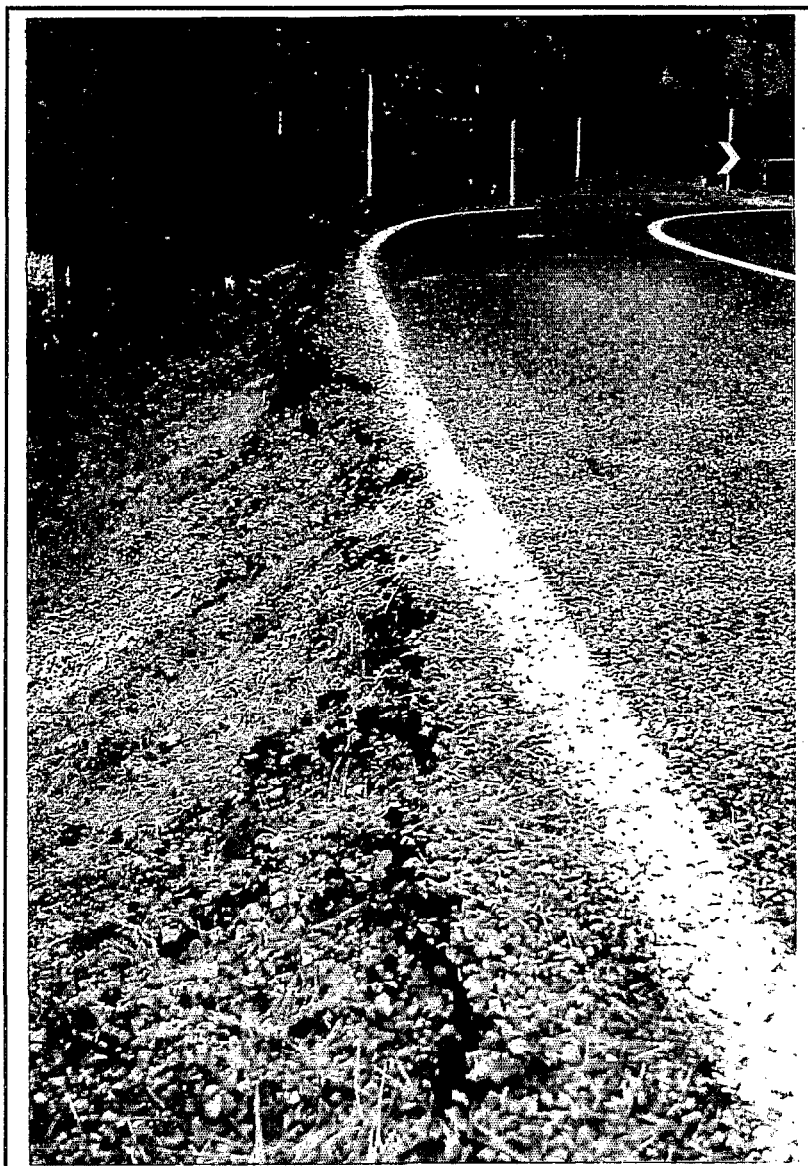
**PHOTO 1 - STEEP FEATHER EDGE SLOPE**

The seal width (typical) on most projects was in the range 5.5m to 6.0m and generally not considered a safety problem. What was of most concern was the practice of achieving the additional seal width by steepening the feather edge slope. **This compromises both safety and the structural integrity of the seal edge and significantly increases future maintenance costs.** This issue is discussed further in Section 4.8: Feather Edge Slopes.

Note lack of edge support, edge break occurring,  
edge line too close to edge of seal

Ideally a feather edge of 5 to 1 should be provided to allow vehicles to safely pull over off the seal. However, it is accepted that for seal extensions with low traffic volumes this is often unrealistic. (Refer photo 1 on page 22).

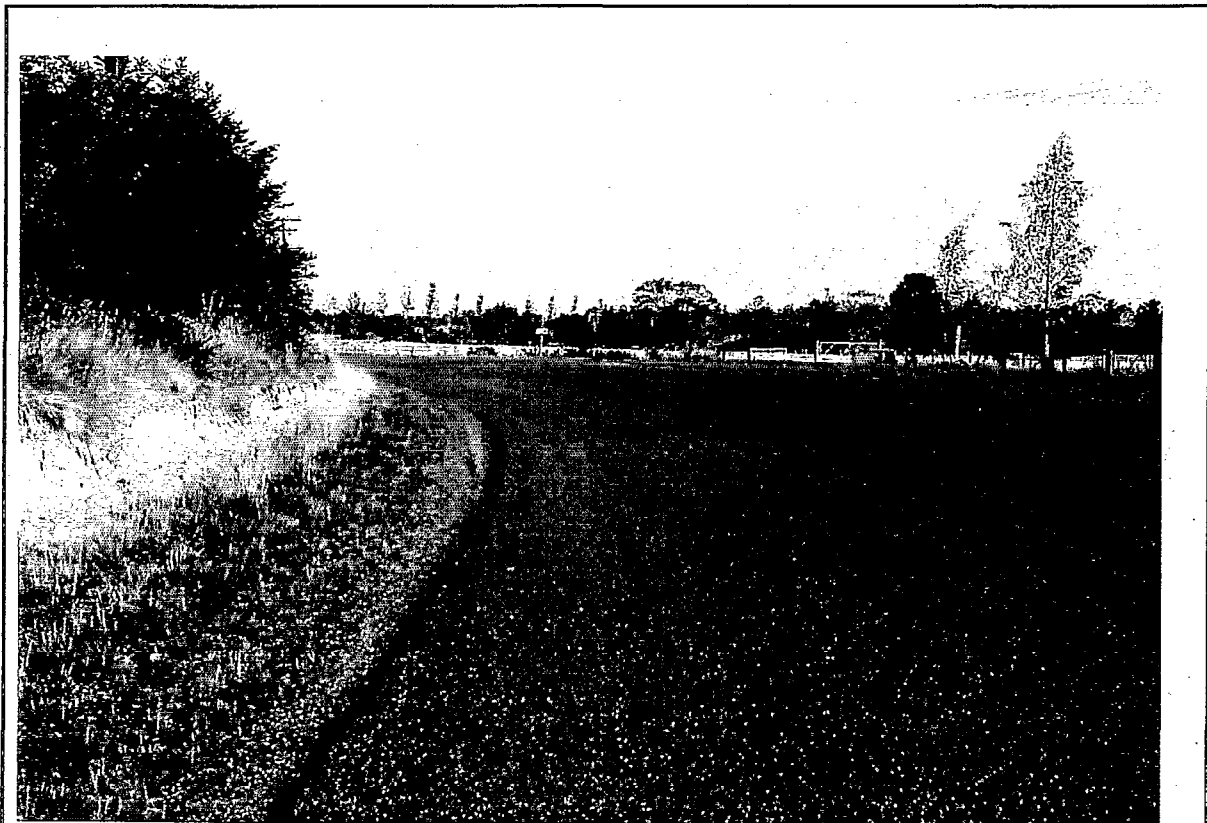
Very few sight distance improvements were included in the projects inspected. In some cases the costs of providing additional sight distance was prohibitive and the compromise accepted by the team, in others the costs appeared to be relatively low. Where costs were low, it was not clear if the opportunity was overlooked or if there was a reluctance to take land.

PHOTO 2 - SUB-STANDARD SIGHT DISTANCE  
Note height of batter and minimal cost of improvements

*That Transfund require scheme assessments to adequately consider sight distance improvements. If accident savings are claimed these must be based on an accurate assessment of future safety costs which should reflect the provision of (or lack of) appropriate sight distance standards.*

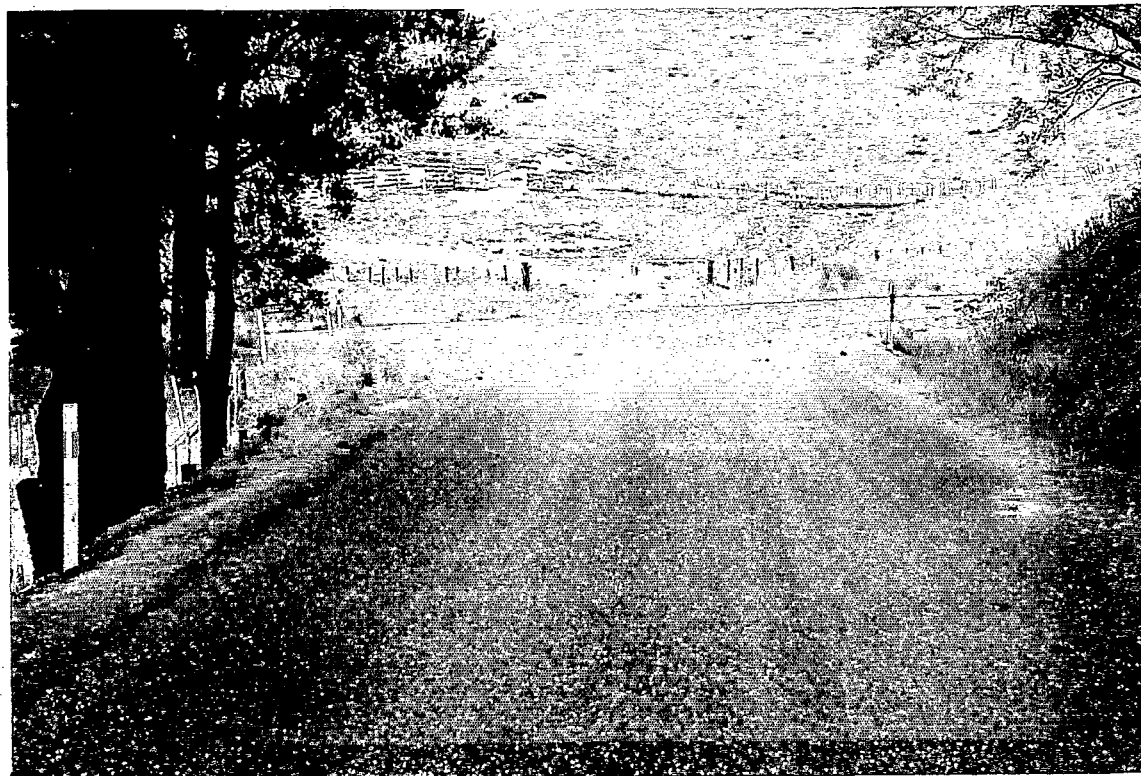
**PHOTO 3 - INTERSECTION DELINEATION/MARKINGS**

Photo 3 on page 25 shows one project where the main route turned to the left and the side road to the right. The roads in both directions were concealed and tyre marks suggested to drivers that the main route was to the right. The intersection finger boards were hidden by trees and not visible until almost at the intersection.

Both roads are concealed and the tyre marks suggest that the main route is to the right (the main route is to the left).

*That Transfund require all designs to comply with good practice/approved standards and guidelines. Additional attention must be given to intersections and access ways at both design, construction and post construction stage. This issue is discussed further in Section 3.5: Post Construction Safety Audits and Section 3.6: Standards.*

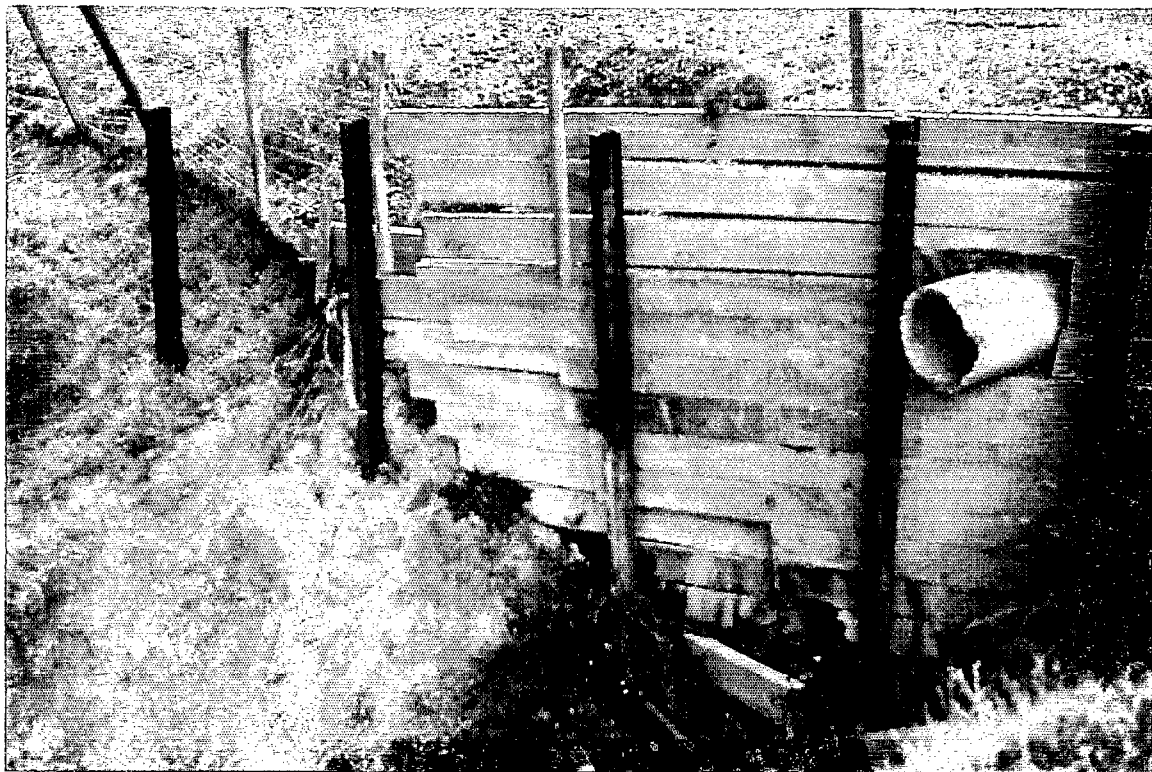
**PHOTO 4 - RETAINING WALLS**

Several retaining walls were poorly constructed and failures had or were occurring. Some obviously had not been designed for the height to which they had been constructed. Also a high proportion were not part of the original project but appeared to be required as a result of inadequate investigations/poor design.

Note the poor design / construction - the uprights have moved significantly and the wall is failing.

*That Transfund require scheme assessments/final designs adequately investigate the need for retaining walls. Road Controlling Authorities must ensure that retaining walls are properly designed and the design height is not exceeded. See also Section 3.3: Scheme Assessments.*

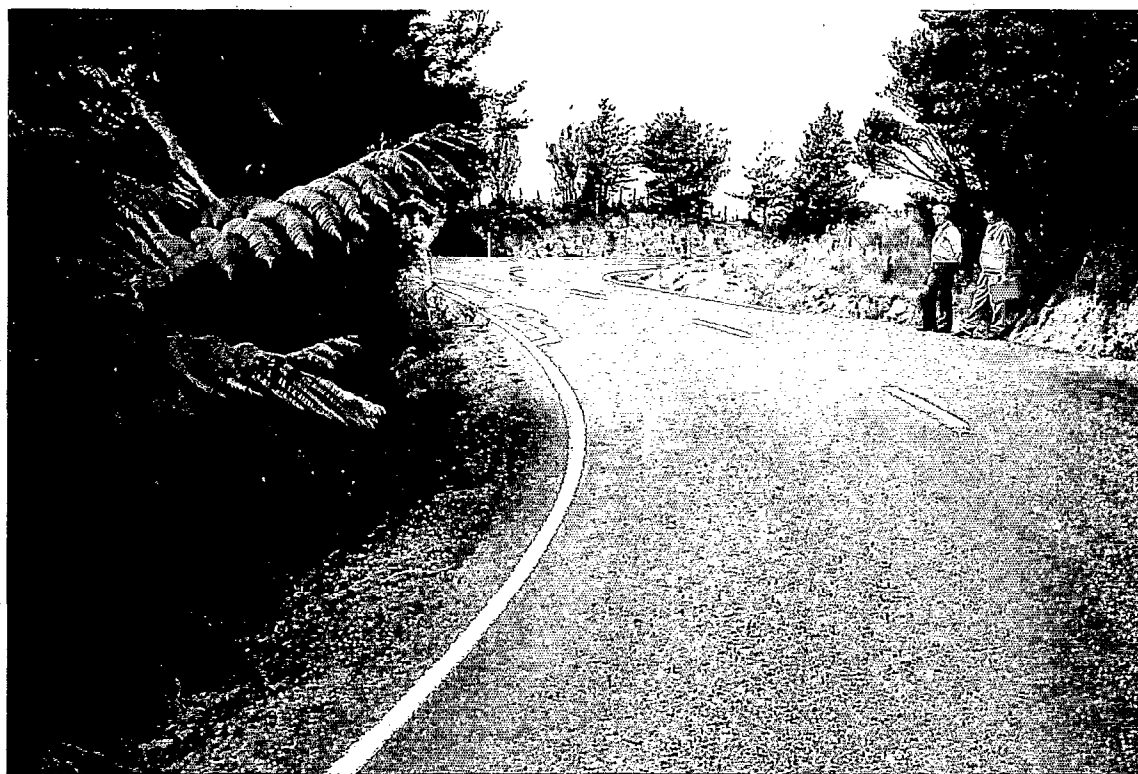
PHOTO 5 - SIGNS

Of the seal extensions inspected only very limited number of signs had been installed and it appeared the provision of advisory signs had been given insufficient consideration. There was particular concern at the lack of curve signs on long horizontal curves which had inadequate sight distance and design speeds well below that of the adjacent curves. Most other common sign problems also involved horizontal curves. The team noted a lack of advisory speeds plates, poorly located signs, inadequate sizes and signs obscured by vegetation.

Note: The curve in the background is very tight and has a very large deviation angle. The curve sign is hidden by vegetation and has no advisory speed.

*That Transfund require Road Controlling Authorities to ensure that adequate consideration is given to signs. This issue is covered in Section 3.5 Post Construction Safety Audits and Section 3.6: Standards.*

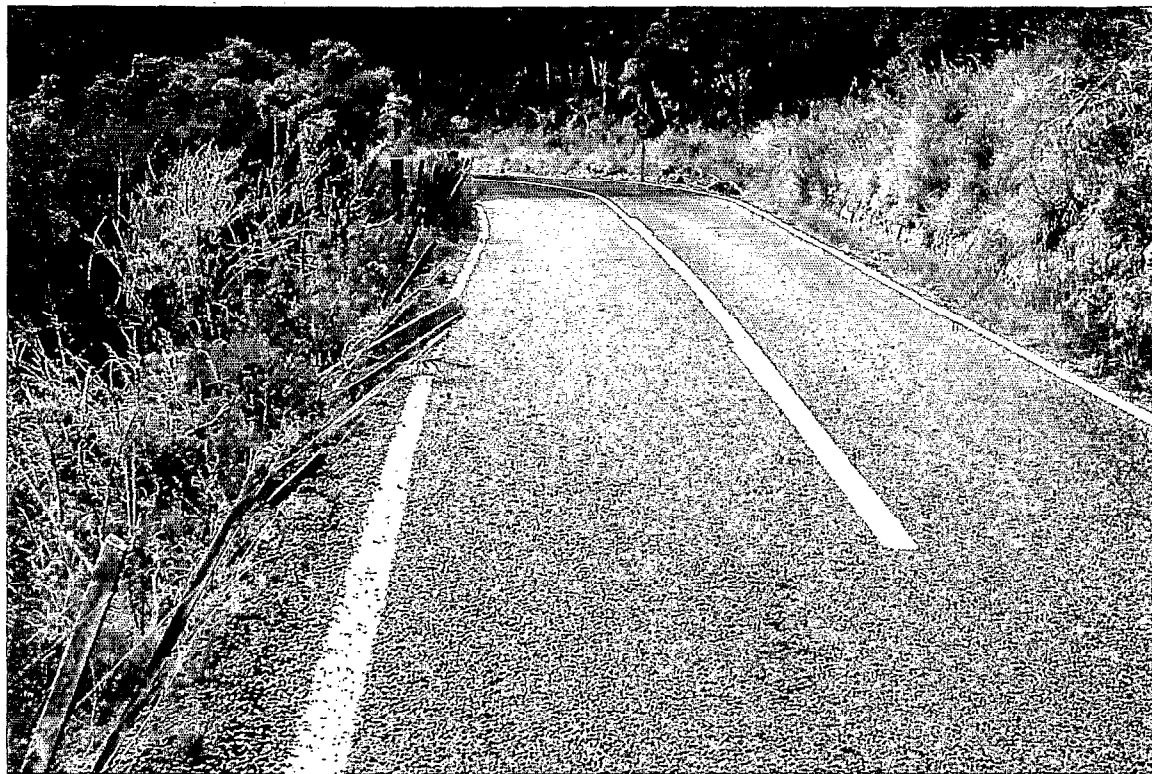
**PHOTO 6 - NON STANDARD LINE MARKING**

The project seal width was generally 4.6m with localised narrowing to 3.7m and extra widening on horizontal curves. Lanes were marked as narrow as 1.5m. The centre line markings were inconsistent with some sections dashed, some solid and others with no centre line. Some solid centre line markings covered a previously dashed centre line. The philosophy behind these markings was unclear and almost the reverse of the RTS5 Guidelines. It was also noted that the standards differed significantly on the adjoining sections with no two sections the same.

Note the seal width is too narrow for lanes lines. One lane measured 1.5m in width.

*That Transfund require all Road Controlling Authorities to generally adhere to national standards for road marking. This issue is discussed further in Section 3.6: Standards.*

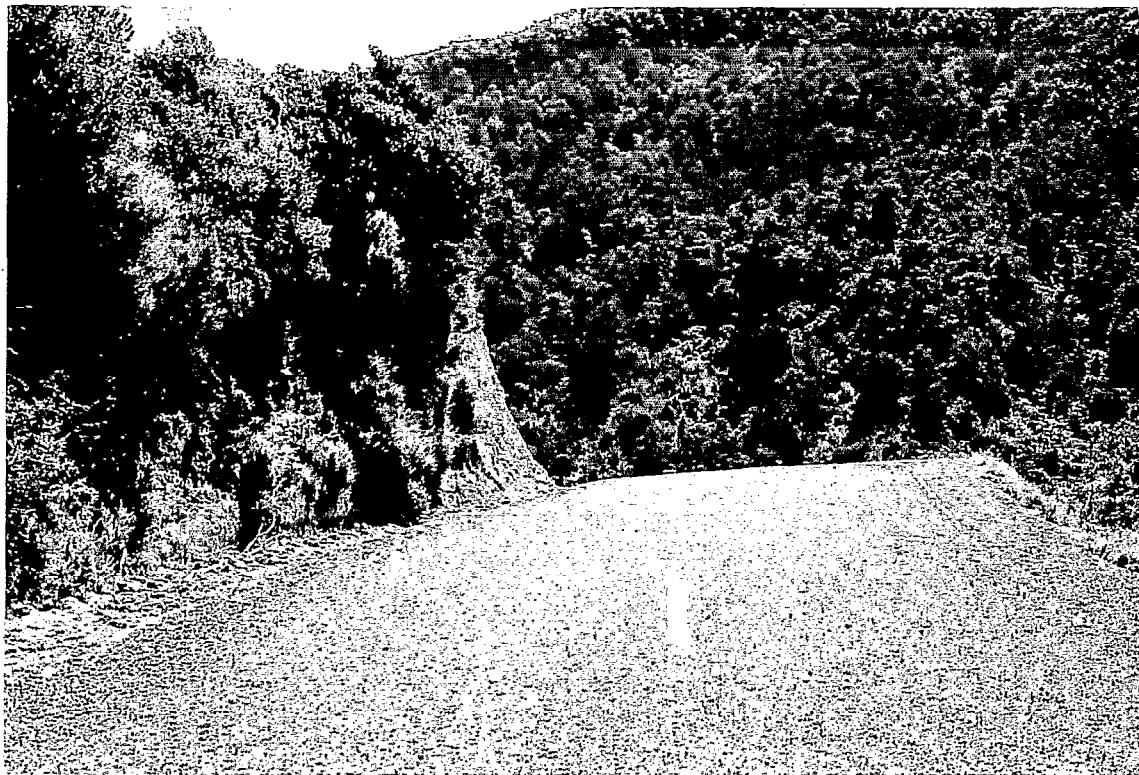
**PHOTO 7 - MARKER POSTS**

- marker posts missing ( this caused considerable concern as the old state highway standard provides only a limited number marker posts and frequently the marker posts missing were the most critical)
- others had the wrong reflectors (mainly white instead of yellow)
- where marker posts had been installed to the new standard there was concern that on the tighter radius curves the spacing between posts was too great (especially where the sight distance around curves was restricted).

Note there is little indication of the forward direction of the road.

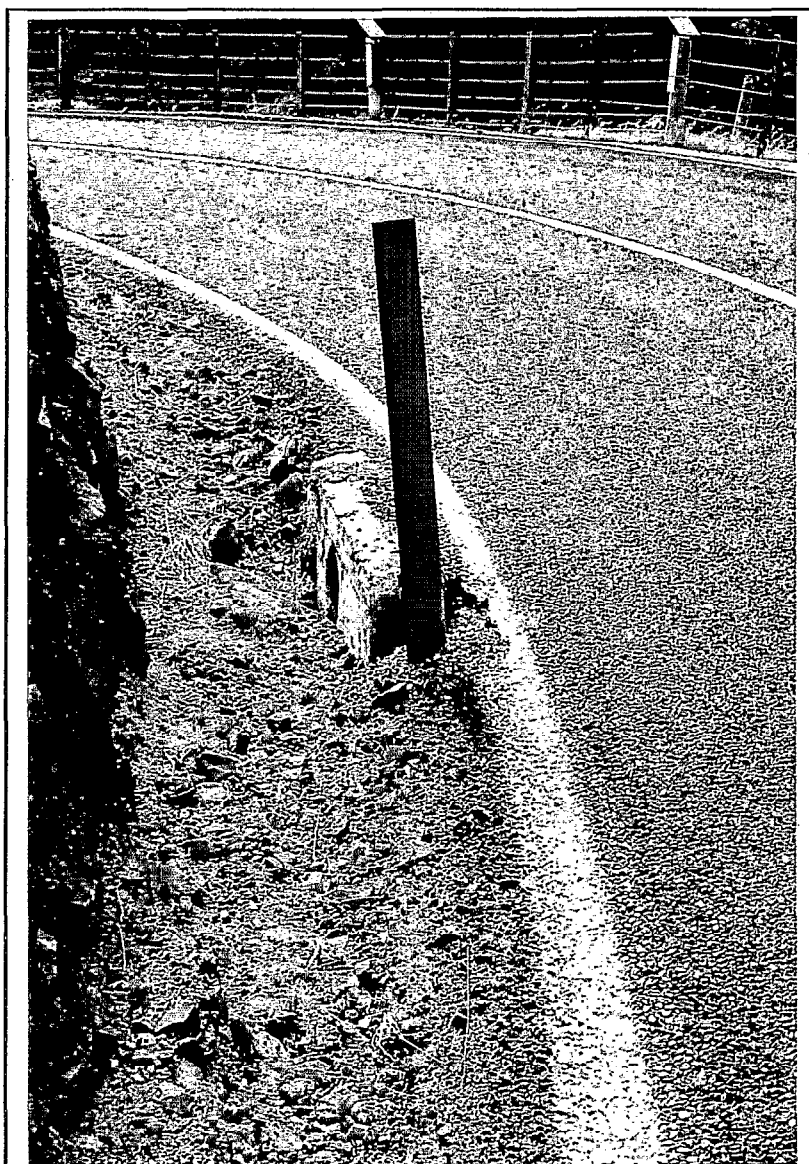
**PHOTO 8 - HAZARD MARKERS**

Almost no use was made of hazard markers. In many locations where one would expect to find hazard markers such as culvert end walls, potential dropout sites etc marker posts had been installed. This gives completely the wrong message to the motorist, especially at night.

Note use of culvert marker where hazard marker appropriate.
